Manhole Inspection Summary

Manhole # S45WW_005MH

Insp Date: **2/7/07 10:43 AM**

Location Address: **1845 30TH ST**

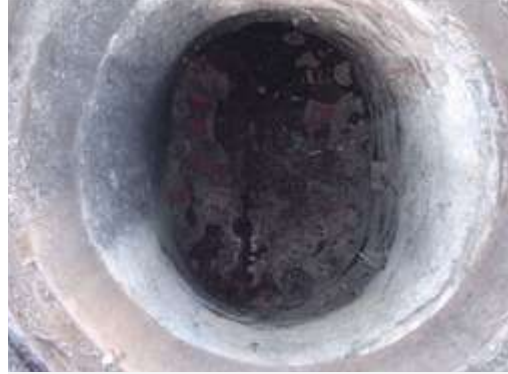
Top View

☒ **Debris** (not Condition related)

Count: **3** Missing: **3** ☐ Corroded

Corroded and missing steps. Channel debris.

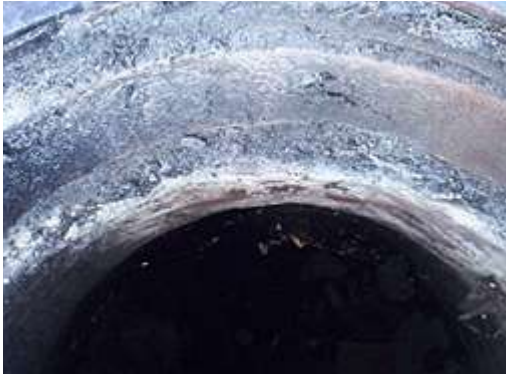
Defect

Offset: **3** (in.)

☒ **Leaks**

Frame leaks. Frame offset.

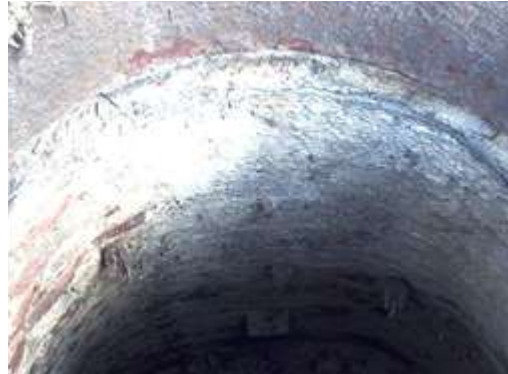
Defect

Infiltration: ☐ None ☒ **Joint** ☐ Cracks ☐ Mortar ☐ Roots ☒ **Wall**

Infiltration: ☐ None ☐ Joint ☐ Cracks ☐ Mortar ☐ Roots ☒ **Wall**

Frame leaks. Adjustment and Barrel infiltration.

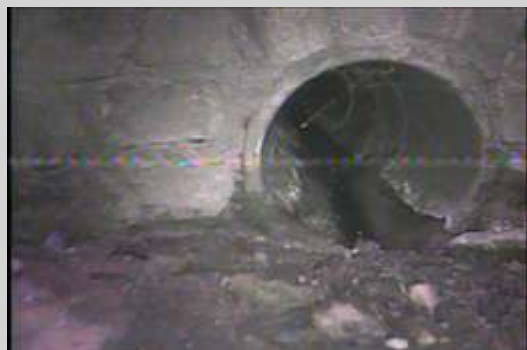
Pipe Out @ 12 O'Clock

Deposits: ☐ None ☒ **Mud** ☐ Sludge ☒ **Debris** ☐ Grease

Silt Depth: **0.5** (in.)

Infiltration: **Evidence**
